## 2.0 Baseline Conditions

## 2.5 Peat Condition Survey and Assessments

### 2.5.2 SLR Peat Condition Surveys

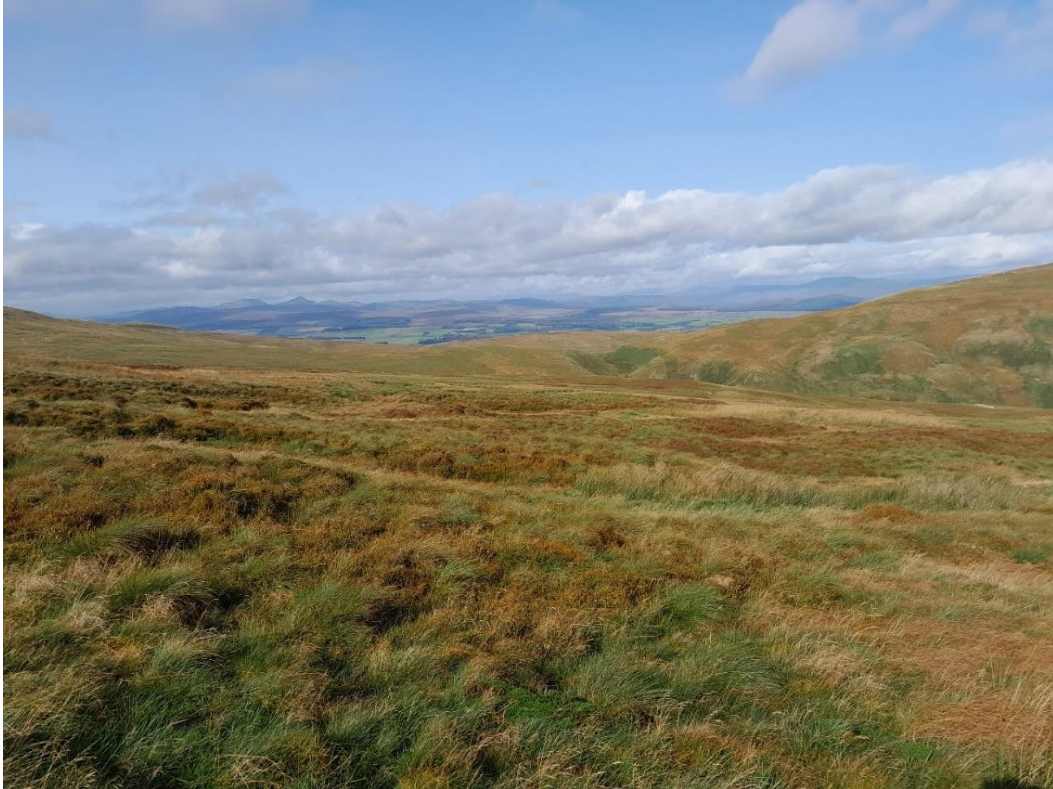
**Photo 1: View facing northwest from NGR NN 88705 03148, showing undulating open moorland, taken on 03/10/2023.**

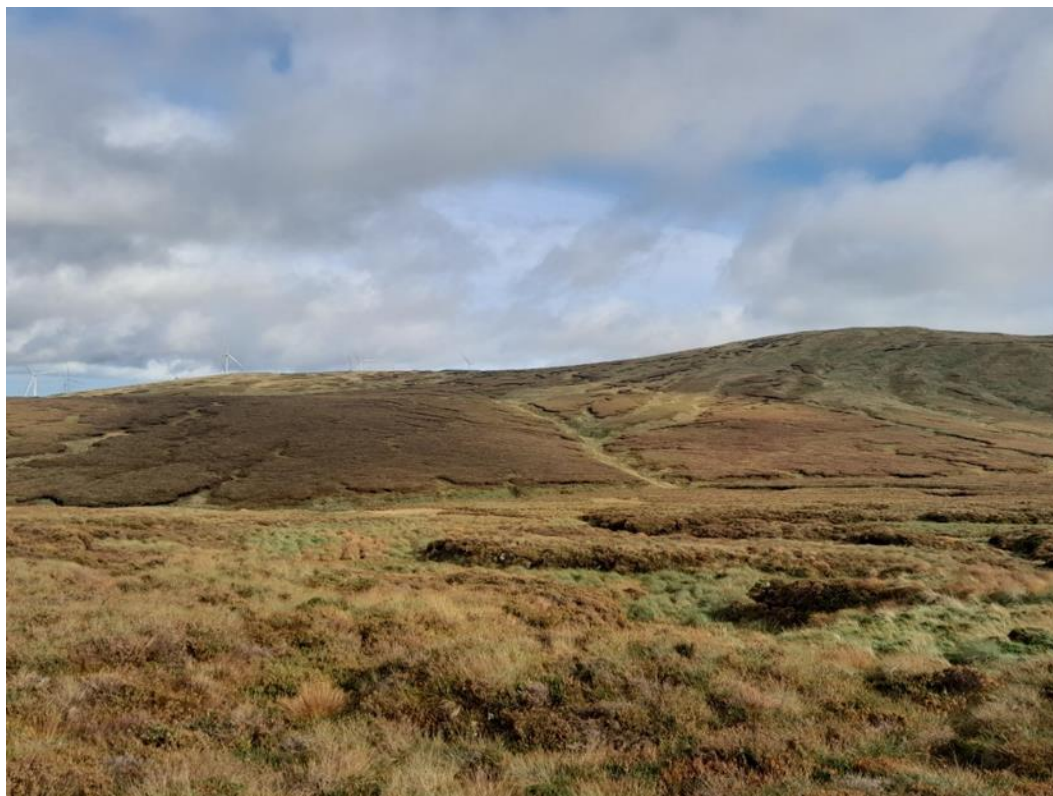
**Photo 2: View facing east from NGR NN 88220 01788, showing areas of peat haggging, taken on 03/10/2023.**

- Area of extensive peat haggling east of Blairdenon Hill that extends to the west of Ben Buck.
- Peat panning was flagged within CES report highlighting revegetation in some areas.
- Effect of extensive historic grazing and current grazing pressures mentioned.
- Limited anthropogenic drainage noted in the CES report within shared areas with this report, drainage mapped to the west outside the site boundary.
- Hagged gulleys are described as being colonised by acid grassland (low mineral soils) with hummocks and limited sphagnum moss being present.

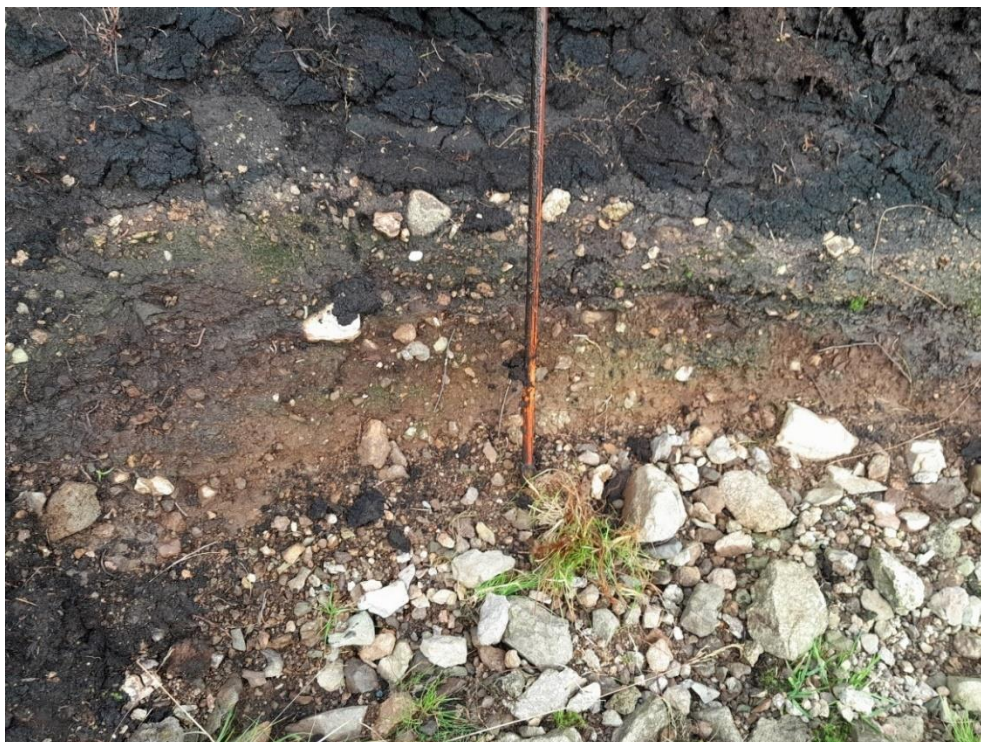
**Photo 3: Peat deposits with underlying glacial till substrate, taken at NGR NN 88137 01873.**

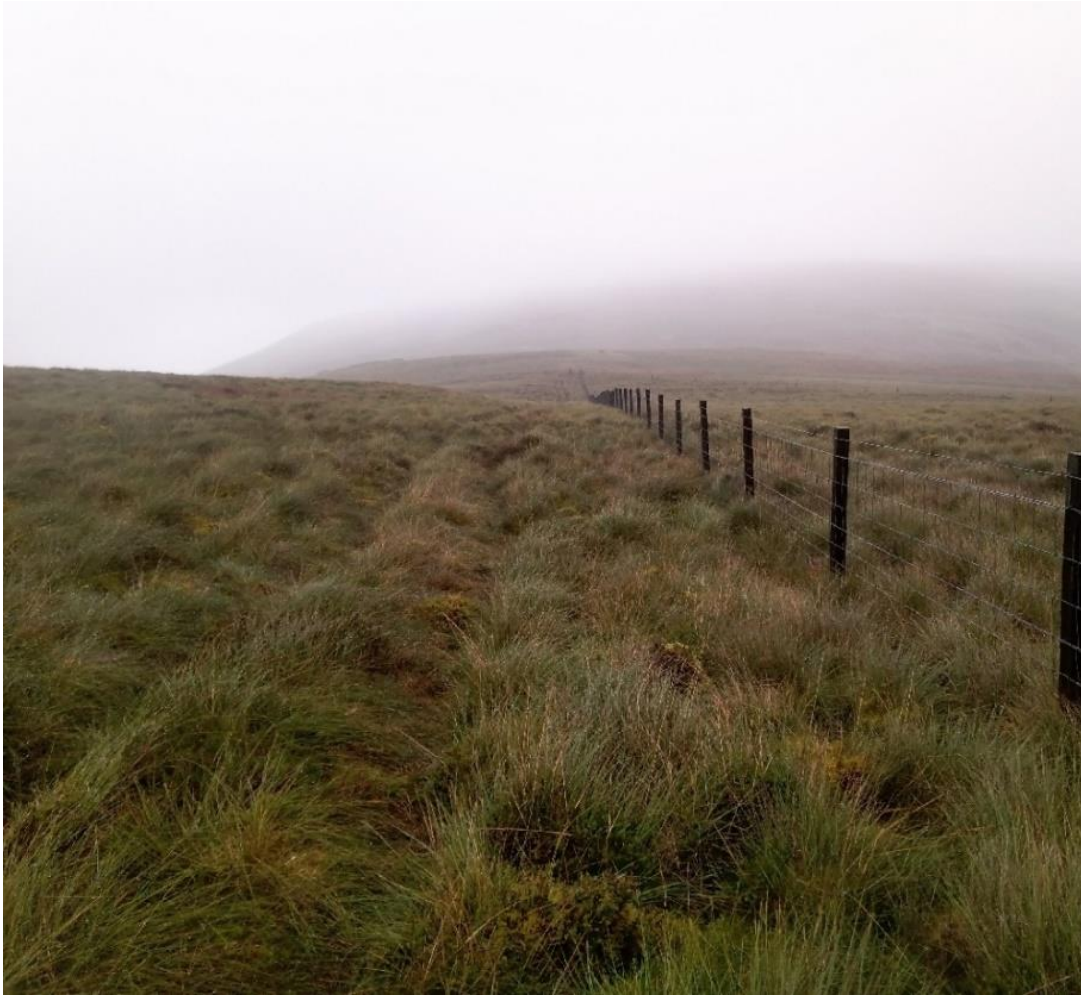
No near natural features were observed within the proposed development from aerial imagery and during site surveys. The entire area has been primarily modified by intensive sheep grazing. Across the southern area of the proposed development there are extensive 'All-Terrain Vehicle' (ATV) tracks. There are also ATV tracks recorded in the northern area of the proposed development.

**Photo 4: ATV tracks trending north to south. Taken from NN 87987 03459 facing north.**

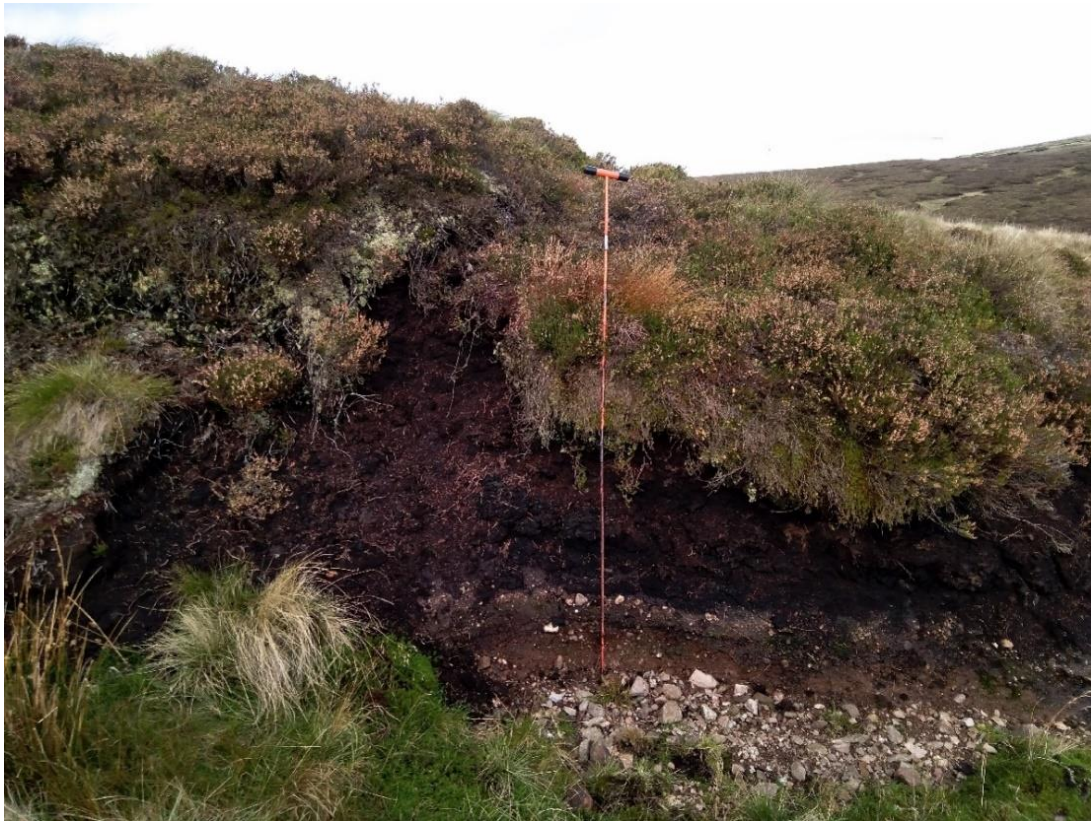
**Photo 5: Revegetation at base of peat hagg with bare substrate. Taken from NN 88135 01876 facing south.**

There are extensive areas of peat erosion across the site (peat haggs, peat gullies, peat pans, bare substrate and micro-erosion). Peat haggs of up to 3m were mapped during site surveys at varying stages of degradation. Active revegetation was observed on some areas of peat haggs and peat pans. Peat pans were mapped between areas of peat haggs and erosion gulleys. Micro-erosion was mapped in the north with limited peat deposits typically present in this area.

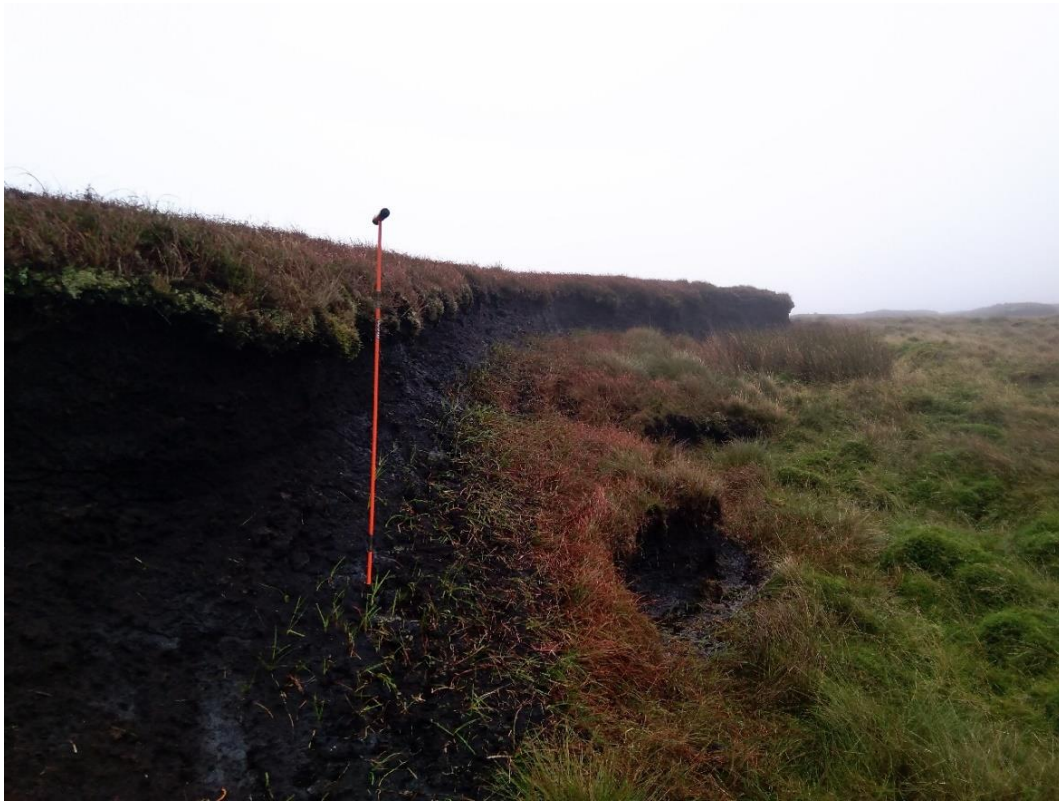
**Photo 6: Peat hagg and regeneration to the north of Turbine 3. Taken from NN 88138 01210 facing southwest.**

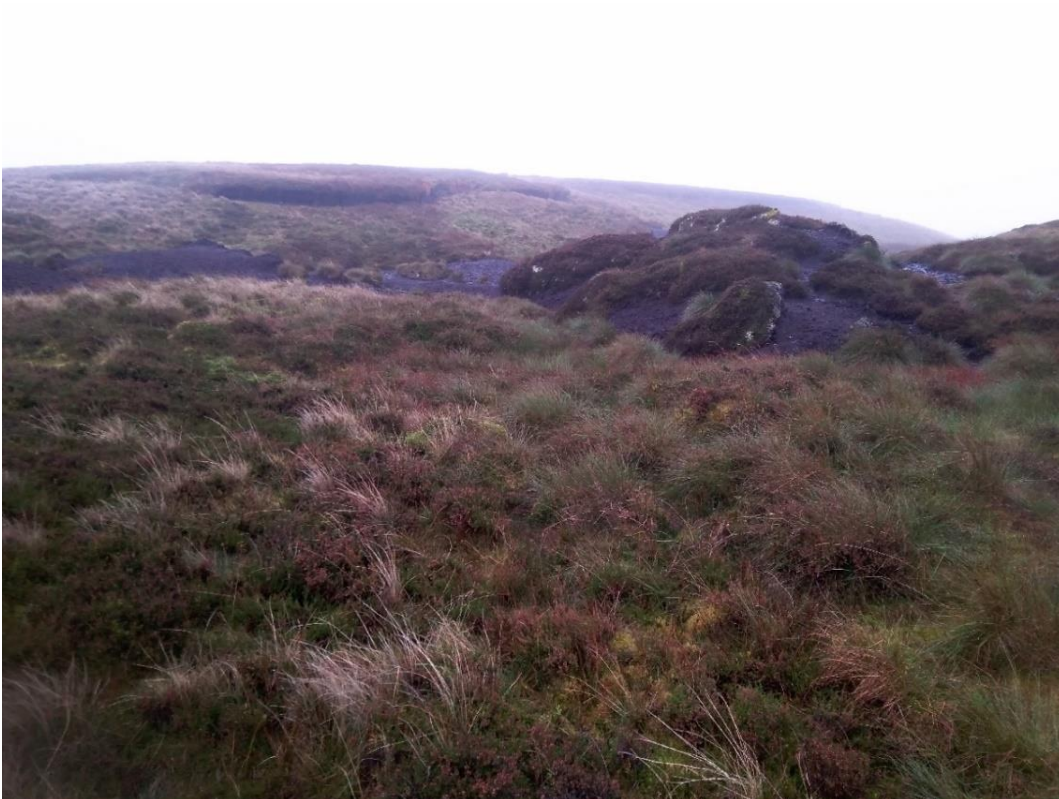
**Photo 7: Peat Pan to the east of Turbine 6. Taken from NN 87737 01716 facing south.**
