Technical Appendix 10.6: Groundwater Dependent Terrestrial Ecosystems (GWDTE) Assessment

Windburn Wind Farm

Windburn Wind Farm Limited

SLR Project No.: 428.V12959.00001

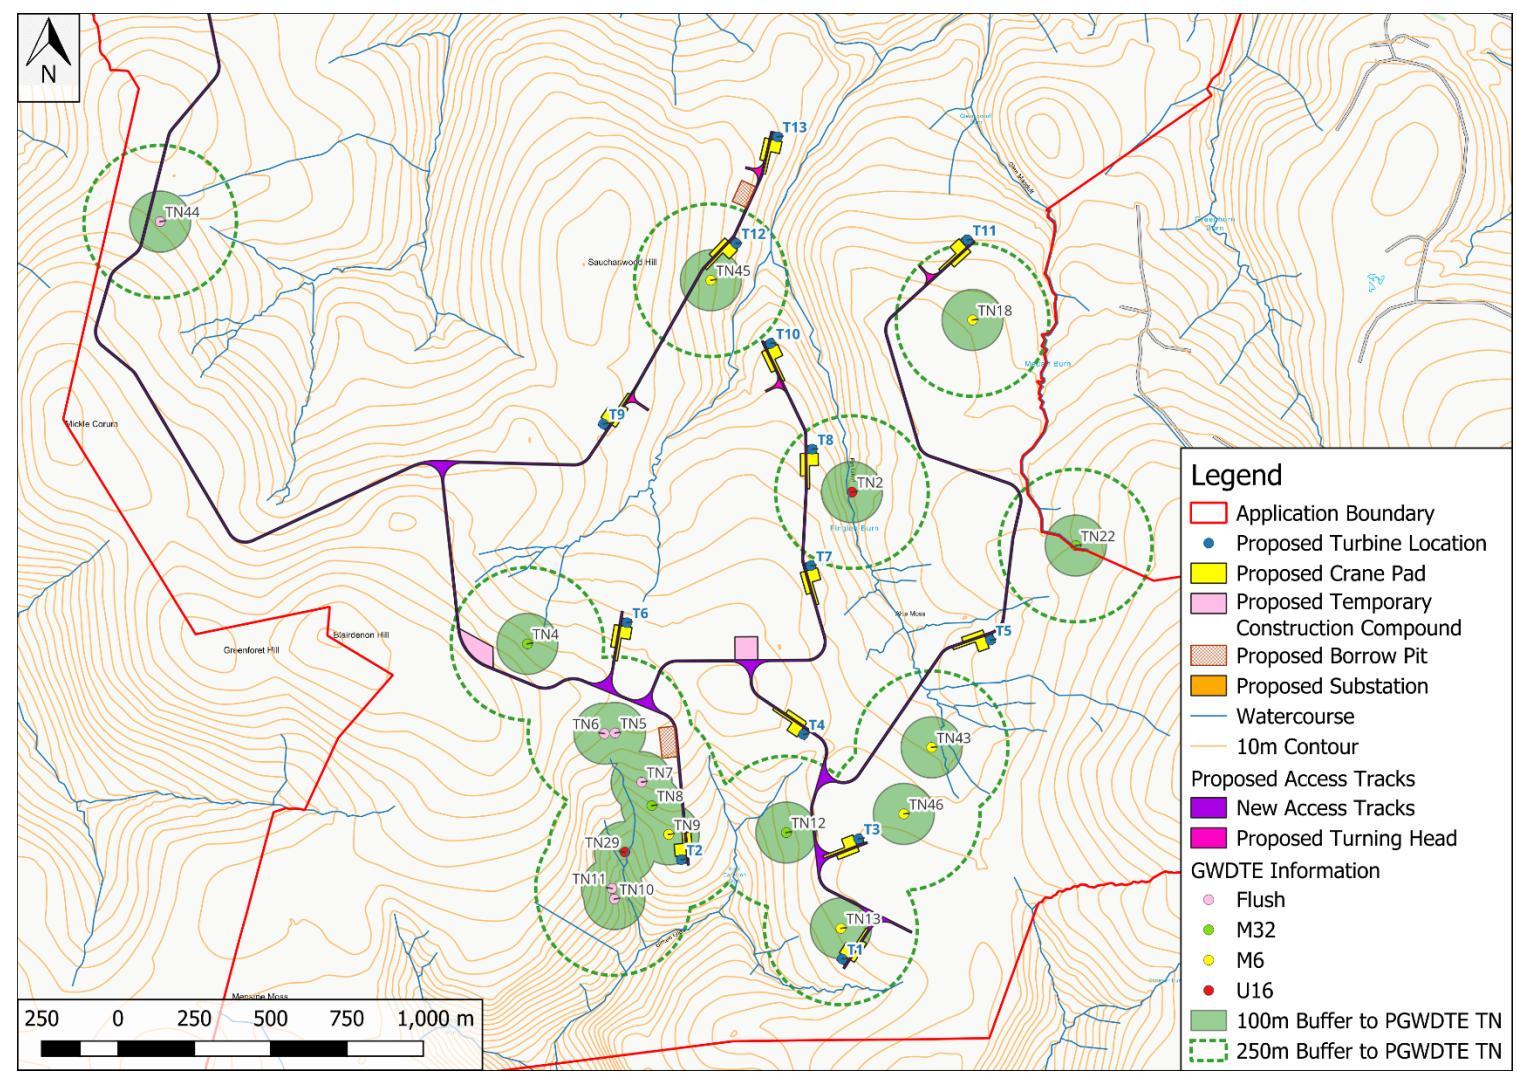
Plate 1: Location of Target Notes

As discussed in **Table 2-1**, further assessment of M6, M32 and flush target notes has been undertaken in accordance with Step 2 of SEPA's guidance. The location of the target notes within 250m of the proposed development are shown on **Plate 1** and are discussed in **Table 3-1**.

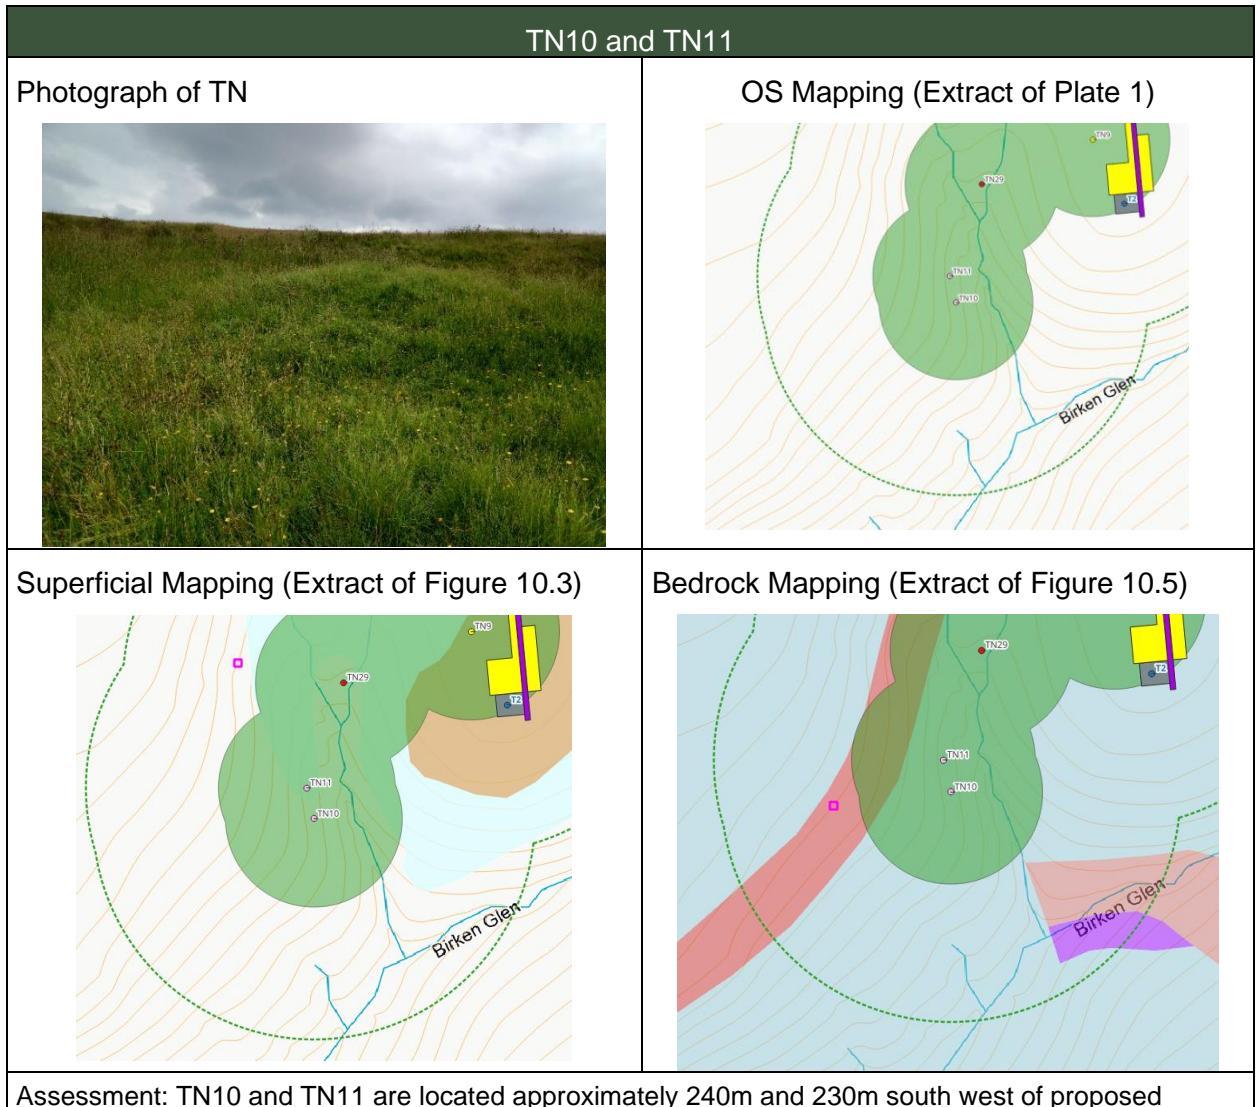
<u>Assessment</u>: TN10 and TN11 are located approximately 240m and 230m south west of proposed turbine T2 hardstanding respectively. The target notes are shown to be underlain by low permeability igneous bedrock.

There is potential for shallow groundwater within the upper weathered surface of the bedrock, however, no development is proposed upgradient of the target notes and therefore it is considered that the water which sustains the target notes will not be impaired by the proposed development.

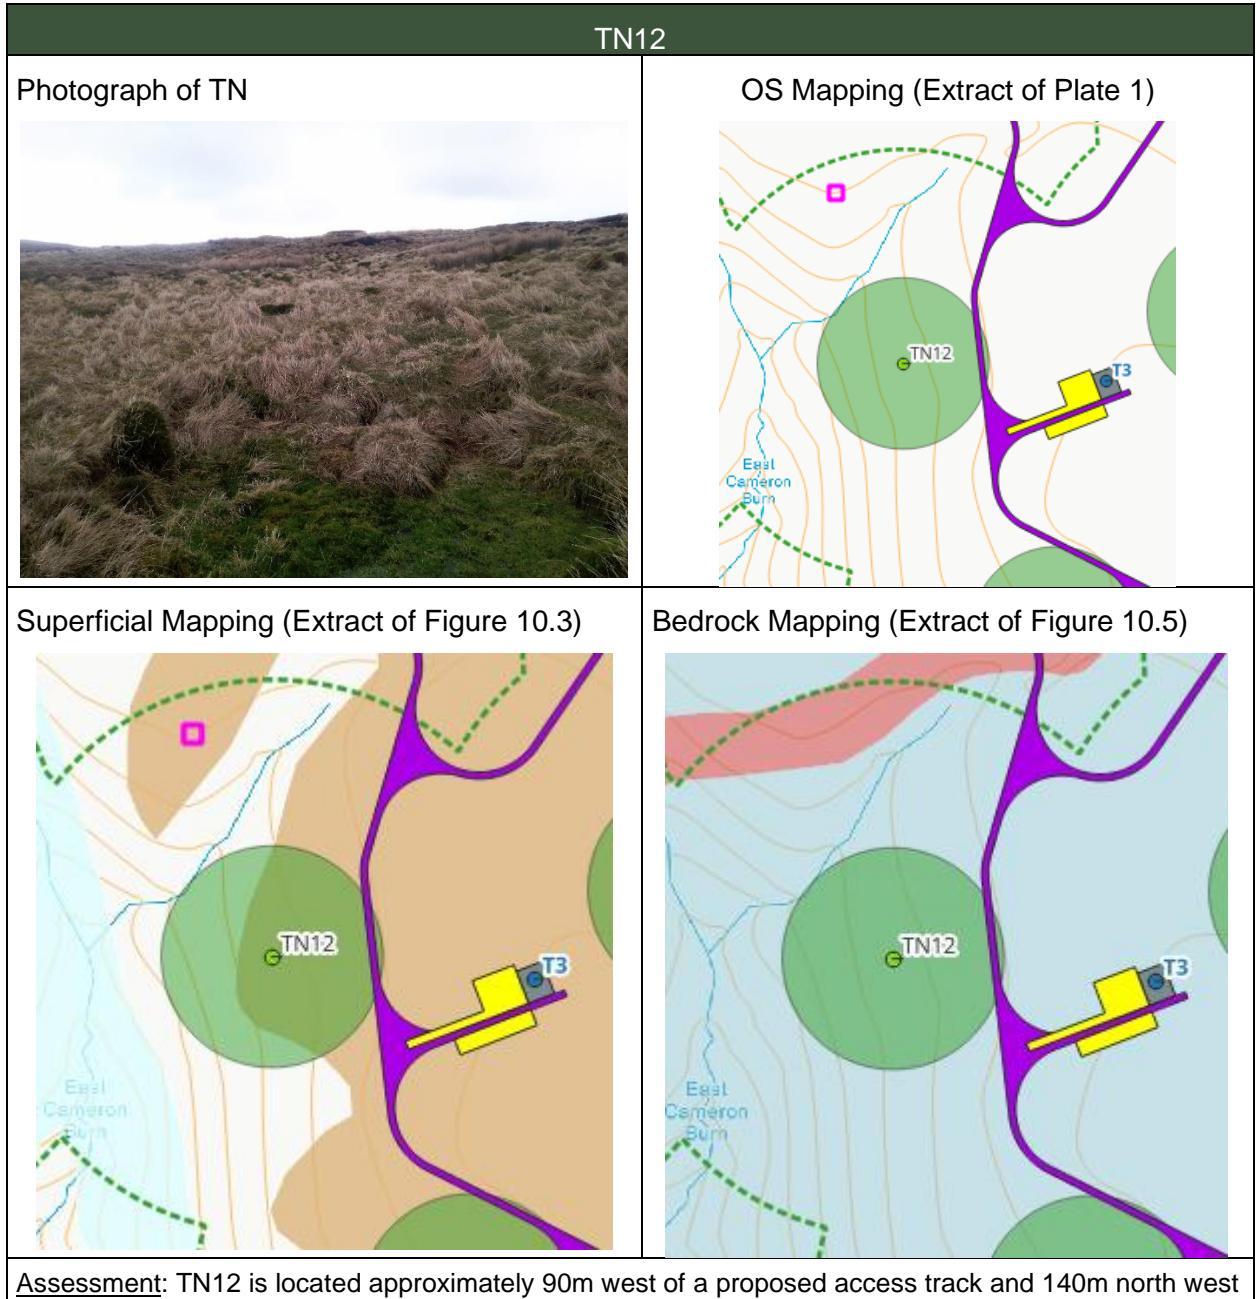
<u>Assessment</u>: TN12 is located approximately 90m west of a proposed access track and 140m north west of the proposed turbine T3 hardstanding. The target note is shown to be underlain by low permeability peat deposits. No groundwater flush or seepage was observed at this location during the site survey, however waterlogged soils were recorded. It is therefore considered that the habitat is sustained by surface water runoff and waterlogging of soils above the low permeability peat deposits.

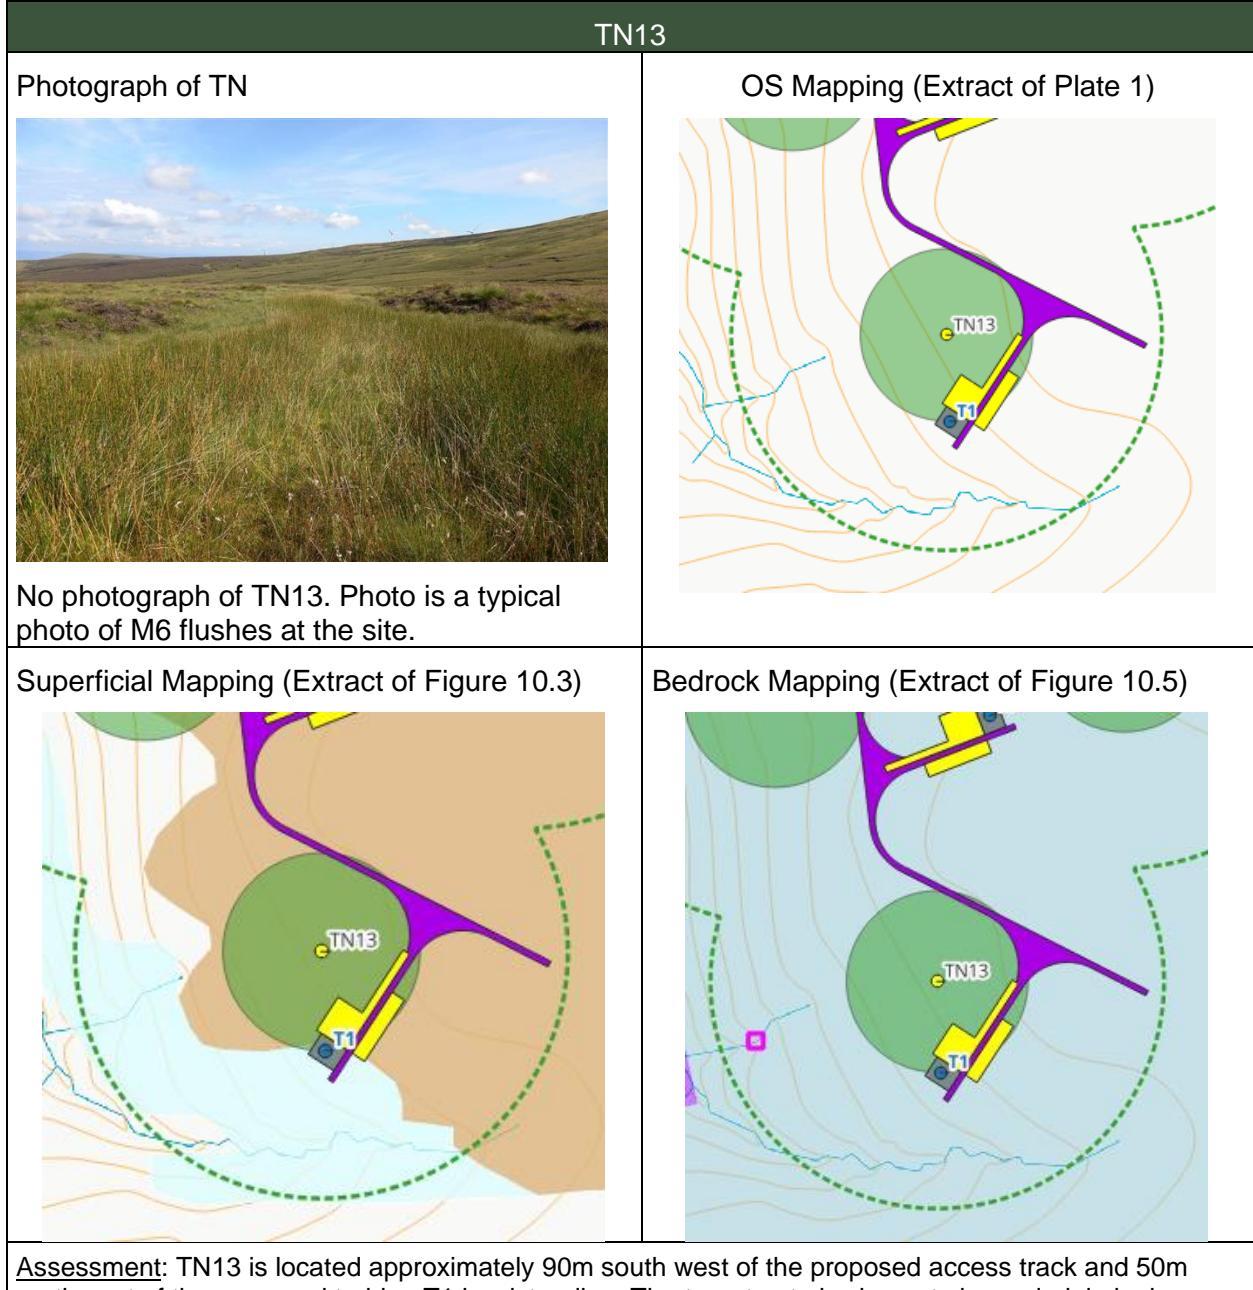
<u>Assessment</u>: TN13 is located approximately 90m south west of the proposed access track and 50m north east of the proposed turbine T1 hardstanding. The target note is shown to be underlain by low permeability peat deposits. There is no change in topography / break of slope nor change in bedrock geology associated with the target note location. No groundwater flush or seepage was observed at this location during the site survey. It is therefore considered that the habitat is sustained by surface water runoff and waterlogging of soils above the low permeability peat deposits.

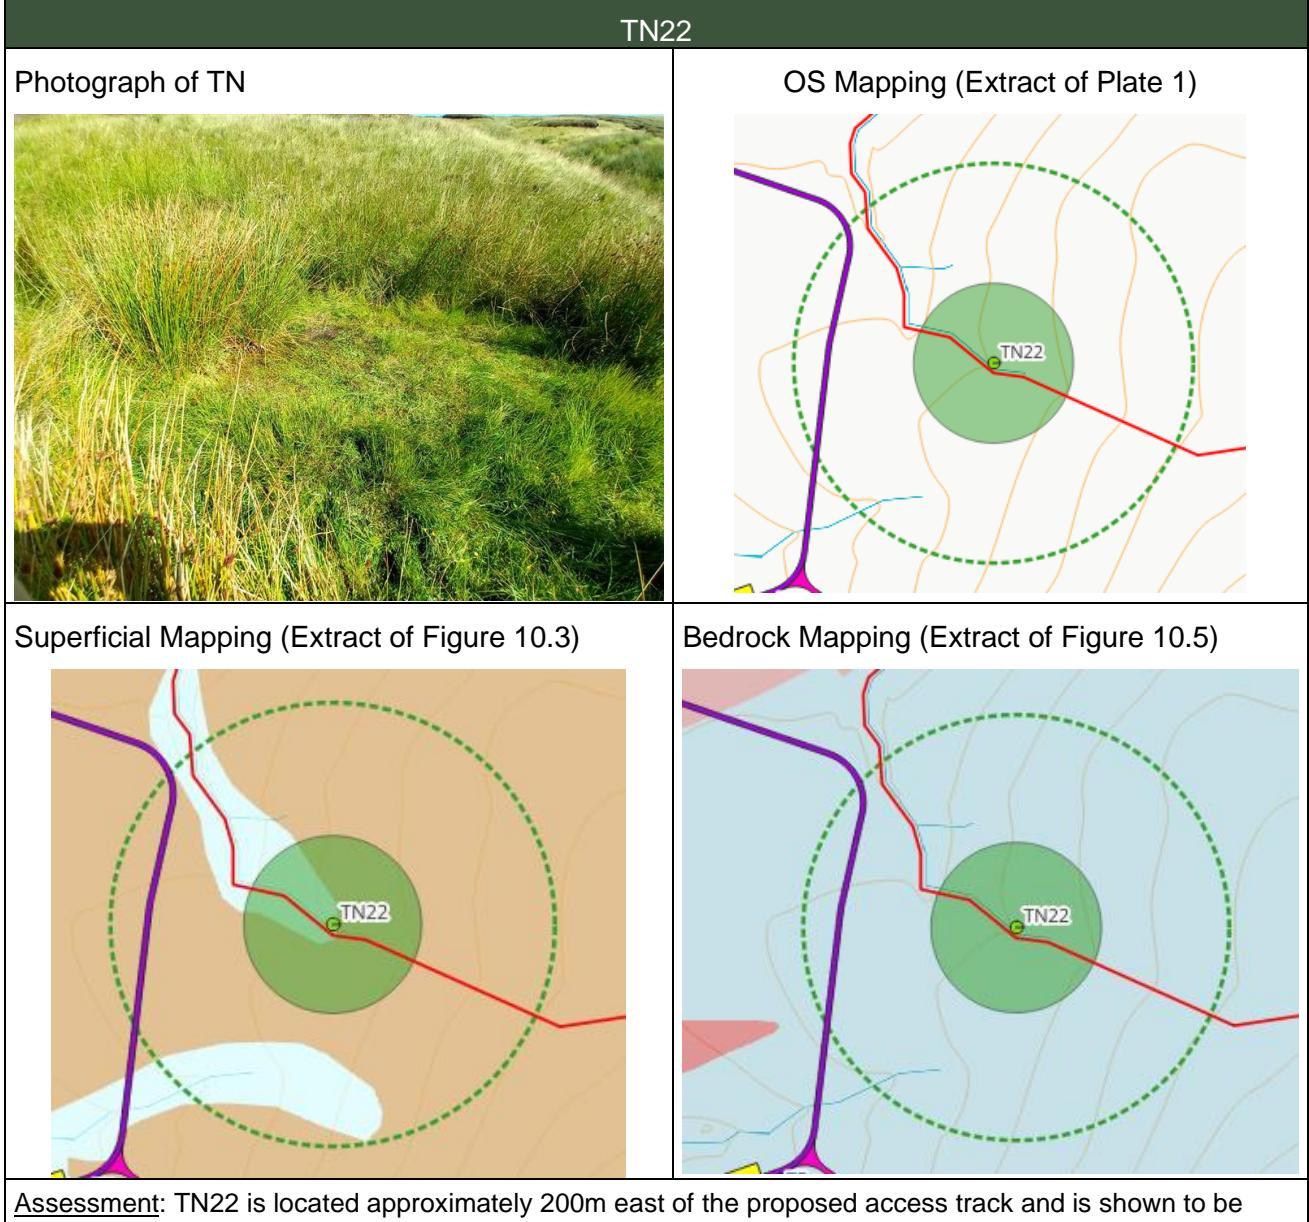
Assessment: IN22 is located approximately 200m east of the proposed access track and is shown to be underlain near the boundary between peat and glacial till deposits, both of which are contain little groundwater. No development is proposed upgradient of the target note and therefore it is therefore considered at risk. The target note is located at a higher elevation than the proposed development.

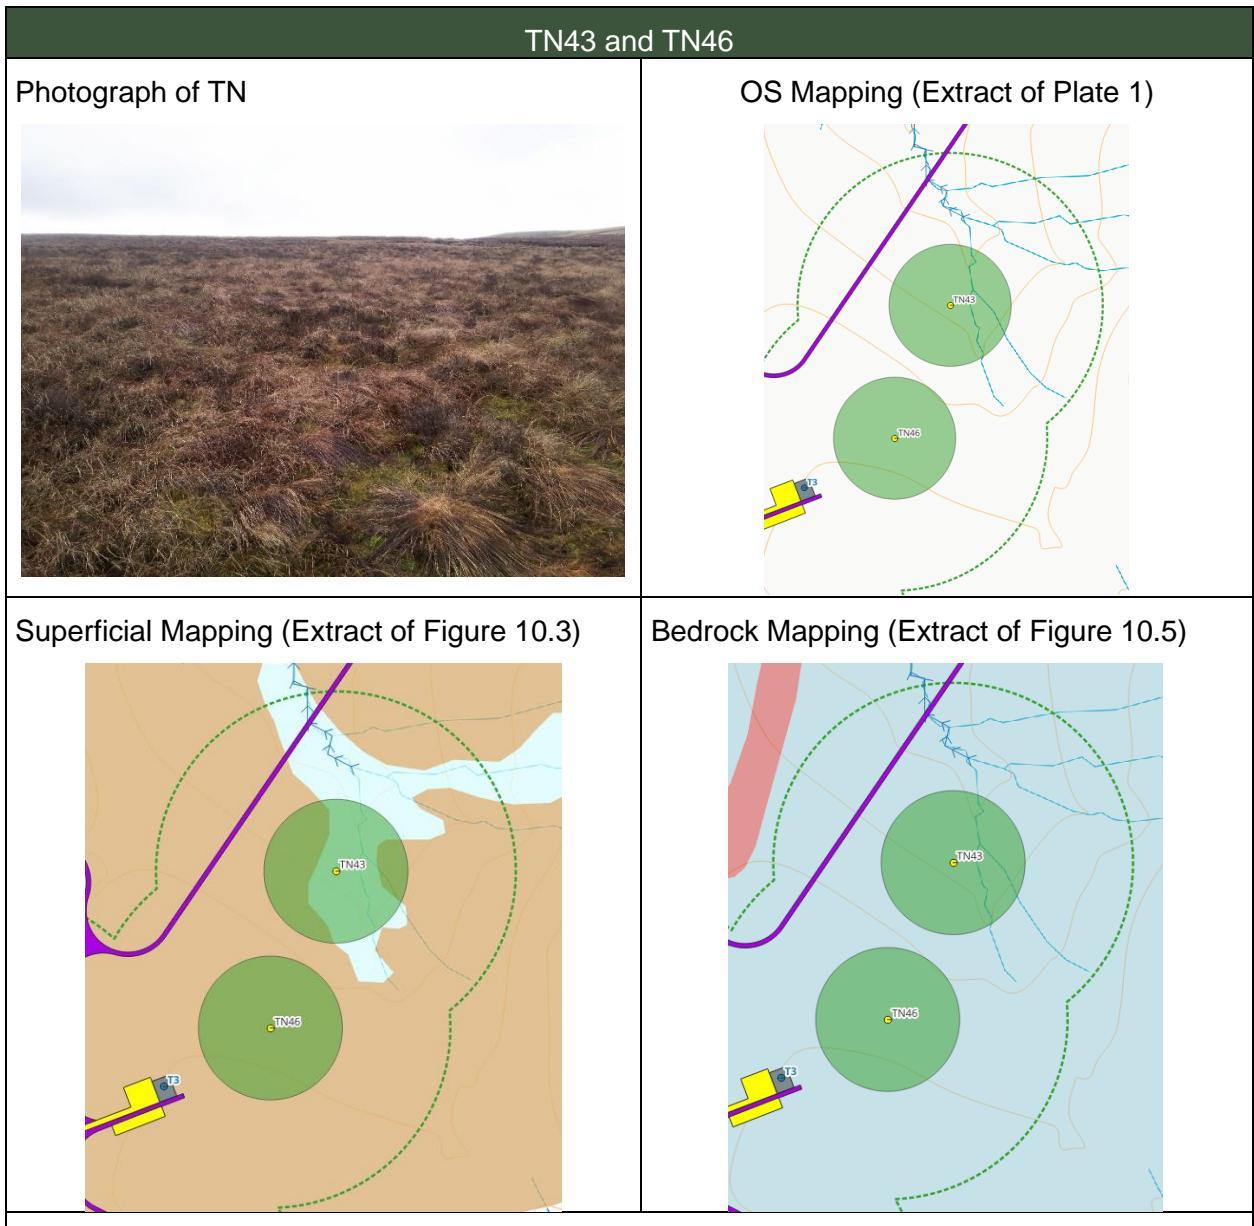
<u>Assessment</u>: TN43 is located approximately 140m south east of the proposed access track whilst TN46 is located approximately 190m south east of the proposed access track and 150m north east of the proposed turbine T3 hardstanding.

The target notes are shown to be underlain by low permeability peat and glacial till deposits. No bedrock geological discontinuity is recorded at the target note locations. No groundwater flush or seepage was observed at these locations during the site survey. It is therefore considered that the habitat is sustained by surface water runoff and waterlogging of soils above the low permeability deposits. In addition, no development is proposed upgradient of the target notes and therefore it is considered that the water which sustains the target note will not be impacted by the proposed development.

Potential impact to GWDTE is assessed as Low and therefore no further risk assessment is required in accordance with SEPA guidance.

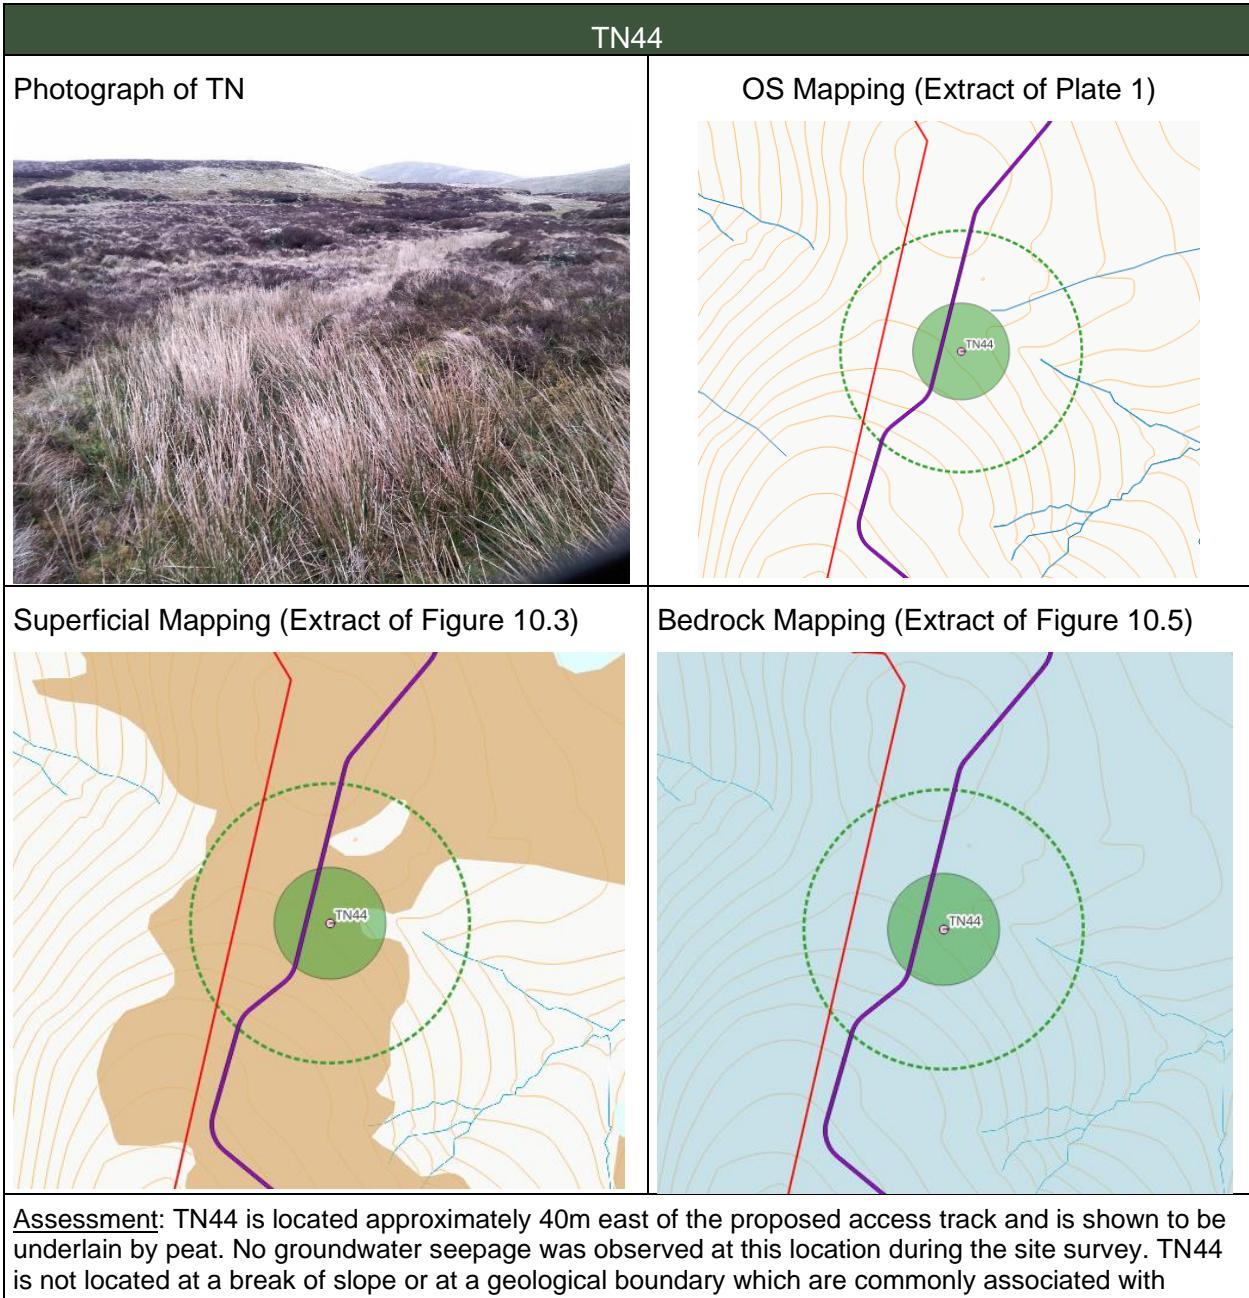
underlain by peat. No groundwater seepage was observed at this location during the site survey. TN44 is not located at a break of slope or at a geological boundary which are commonly associated with emergent groundwater conditions. It is therefore considered that the habitat is sustained by surface water runoff and waterlogging of soils above the low permeability peat deposits. Provision has been made in the EIA Report to maintain existing surface water flow paths.

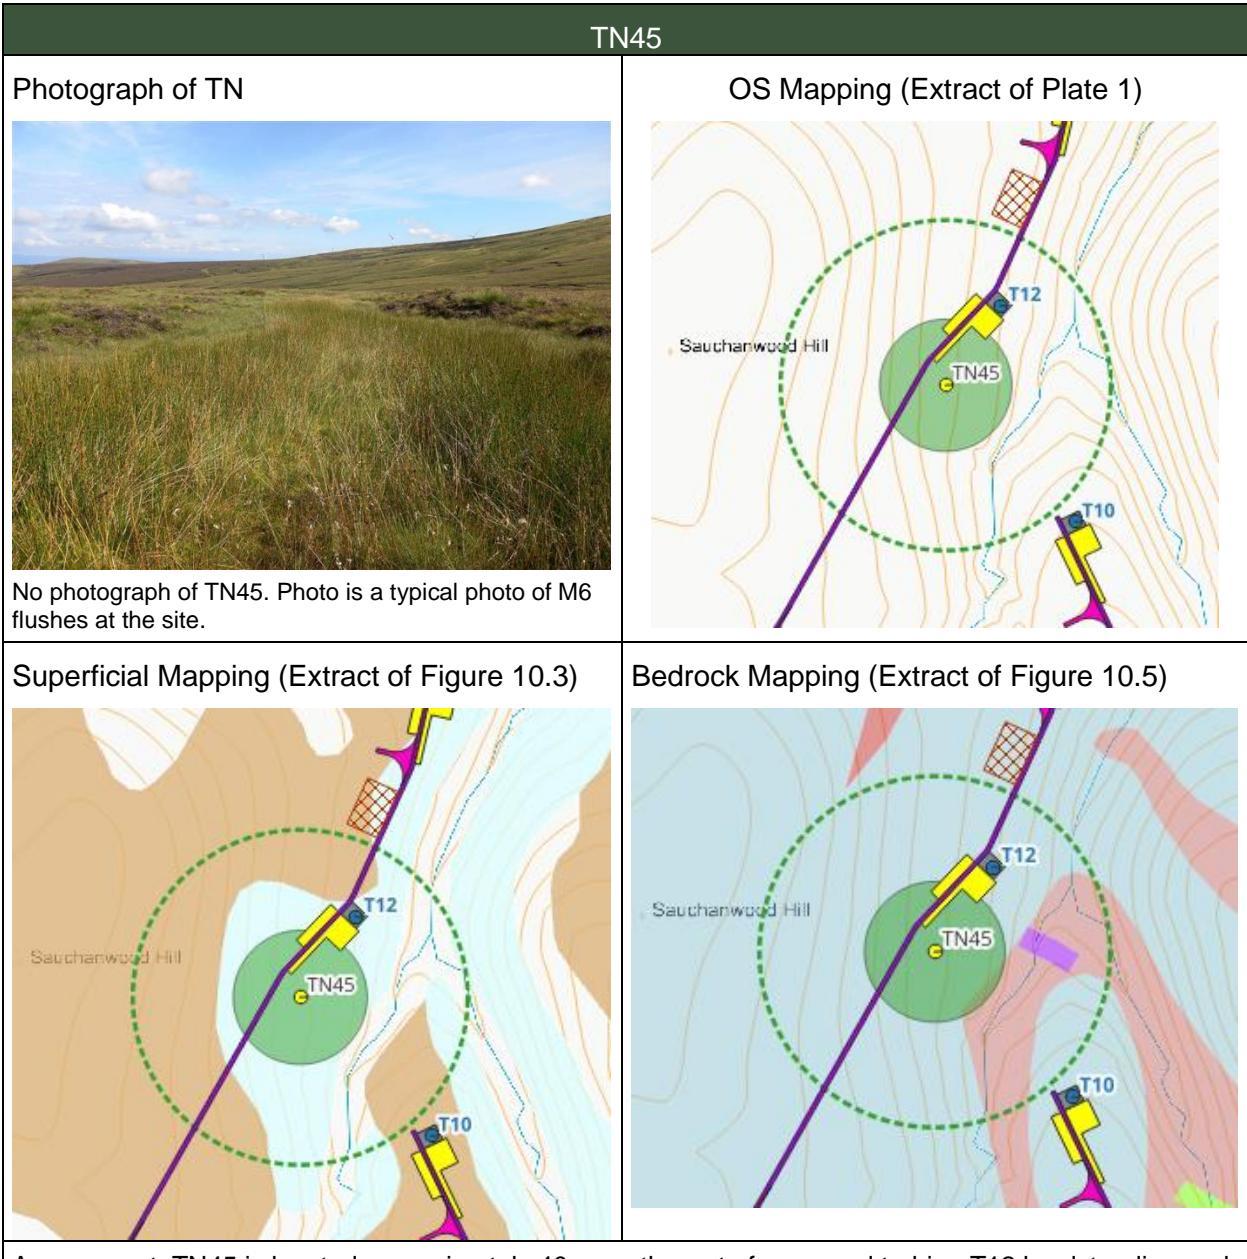
<u>Assessment</u>: TN45 is located approximately 40m south west of proposed turbine T12 hardstanding and is shown to be underlain by low permeability glacial till. No change in bedrock geology is recorded at the target note location. It does not lie downstream of the turbine and therefore any temporary dewatering of the low permeability geology at this location will not impair the habitat at the target note.

The access track to turbine T12 passes west of the target note and upstream of it. Committed best practice measures will be required to maintain surface water flow paths across the track to sustain the habitat.
